CASE STUDY – FEBRUARY 2023

Preventing Catastrophic Failure of a Boiler Feed Water Pump with dures® XPC-2

Application: BB3 Horizontal Axially Split Multistage Pump operating as a Boiler Feed Water Pump in a Chemical Plant

Issue: Premature Pump Radial Bearing Failure

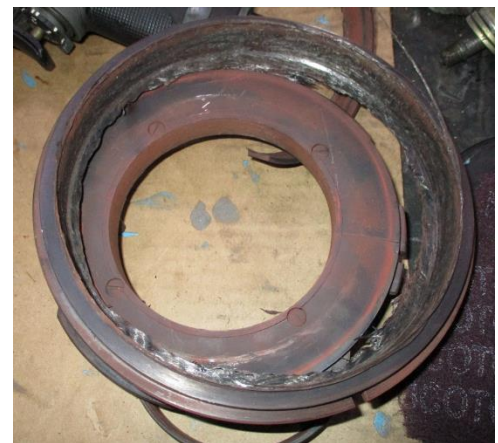
Having worked on the stationary components for this 5-Stage BB3 Horizontal Axially Split Multistage Pump, we were fortunate to have all the pump specifications, measurements, and load requirements. During the initial consultations, we learned that the pump’s radial bearing failure (which was a third-party component) resulted in an ~.125” (3.2 mm) drop in the rotating assembly creating a hard rub condition between the rotating and stationary components at all wear ring and bushing locations.

Case Wear Ring: Evidence dures® XPC-2 components acted as sacrificial components protecting the pump from total loss

With metal-on-metal parts, this could have been so much worse than a temporary pause in pump operation. This could have resulted in a catastrophic failure leading to the frictional welding of the rotating and stationary components requiring the complete rotating assembly to be replaced.

During the assessment, we were able to see the performance of the retrofitted parts provided by CDI and clearly see the positive impact seen with dures® XPC-2. It was clear from the visual inspection that the CDI components acted as sacrificial components protecting the pump from total loss. The pump impellers, which optimize flow while minimizing turbulence and maximizing efficiency, were salvaged with a minimal skim cut to bring all impeller wear rings to a nominal dimension and surface finish.

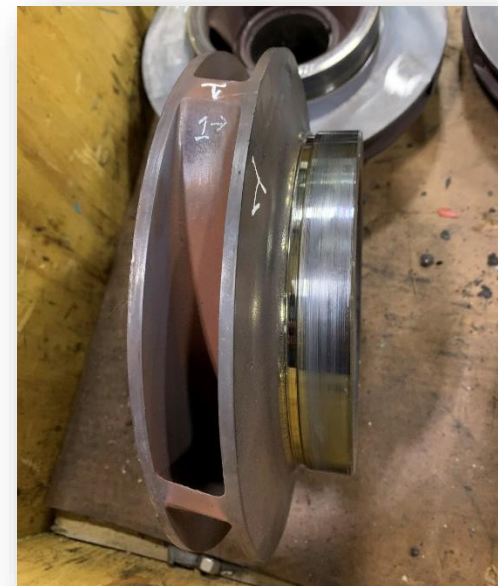
Impeller Wear Ring: Minimal damage after running against dures® XPC-2 case wear ring
