CASE STUDY – FEBRUARY 2023

Preventing Catastrophic Failure of a Boiler Feed Water Pump with dures® XPC-2

Application: BB3 Horizontal Axially Split Multistage Pump operating as a Boiler Feed Water Pump in a Chemical Plant

Issue: Premature Pump Radial Bearing Failure

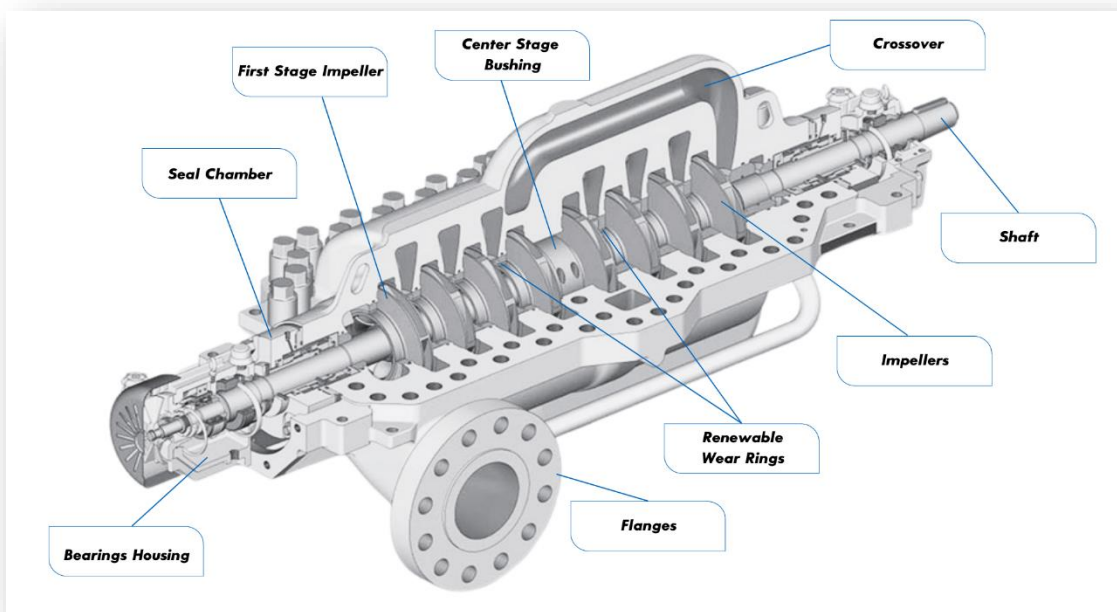
*Example of API 610 BB3 Horizontal Axially Split Multistage Pump with Key Stationary and Active Components
Pump Shown is an 8-Stage Pump*
